# Aviation Investigation Final Report

| <b>Location:</b> | Hydro, Oklahoma | <b>Accident Number:</b> | CEN24FA094 |
| <b>Date &amp; Time:</b> | January 20, 2024, 23:23 Local | <b>Registration:</b> | N295AE |
| <b>Aircraft:</b> | Bell 206 | <b>Aircraft Damage:</b> | Destroyed |

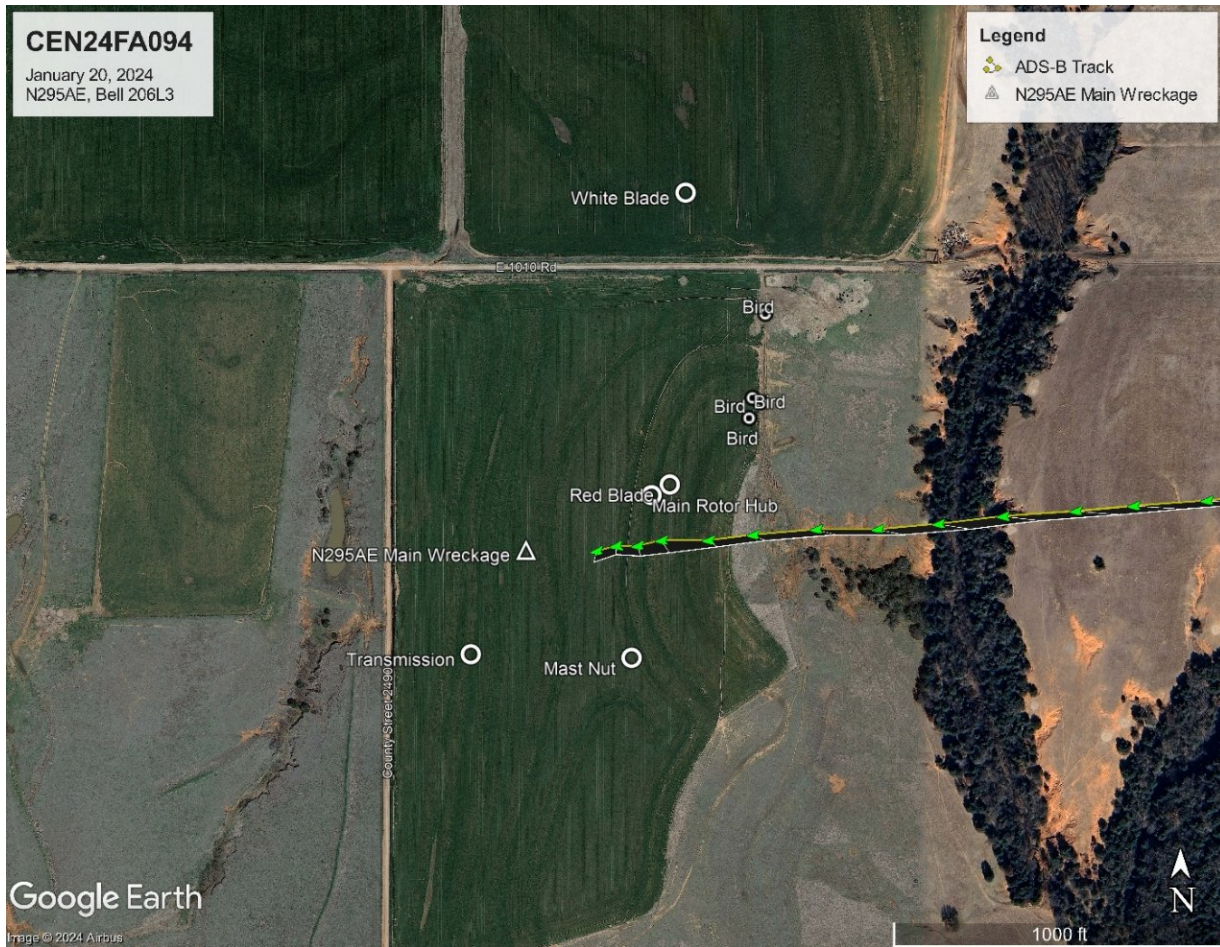
ADS-B data captured the accident flight as it departed OL16 and flew west towards OL16 between 500 ft and 600 ft above ground level and about 110 knots groundspeed. The last ADS-B point was at 2323:39 about 210 ft east of the main wreckage location (see Figure 1).

**Figure 1.** ADS-B Flight Track with Wreckage and Bird Locations

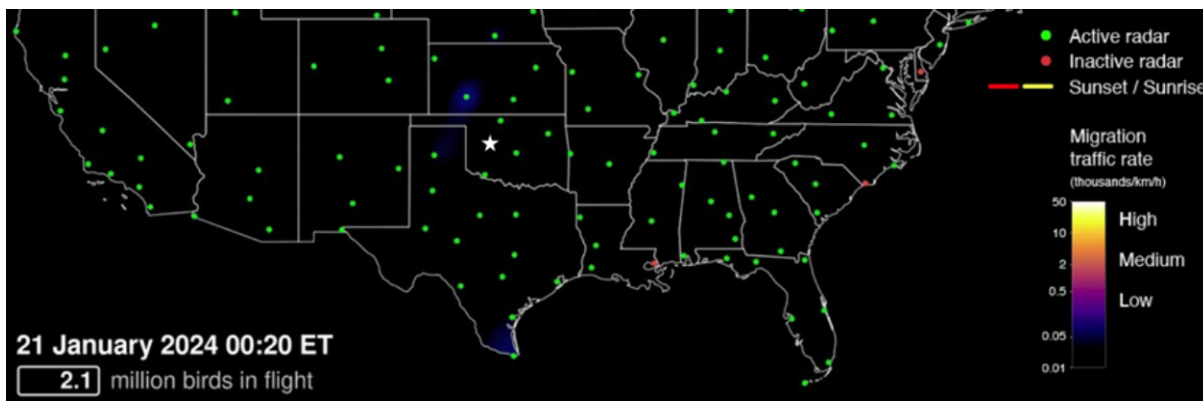
In addition, another bird avoidance resource, BirdCast, uses a collaboration of radar and spotter information to provide near-real-time models of bird activity. A review of historic data contained on their website showed no significant bird activity in the vicinity of the accident (see Figure 2)

**Figure 2.** BirdCast Information – Accident location annotated by a white star.
