# Aviation Investigation Preliminary Report

| <b>Location:</b> | Owenton, KY | <b>Accident Number:</b> | ERA25FA005 |
| <b>Date &amp; Time:</b> | October 7, 2024, 17:35 Local | <b>Registration:</b> | N230AE |
| <b>Aircraft:</b> | Bell 206L-3 | <b>Injuries:</b> | 3 Fatal |

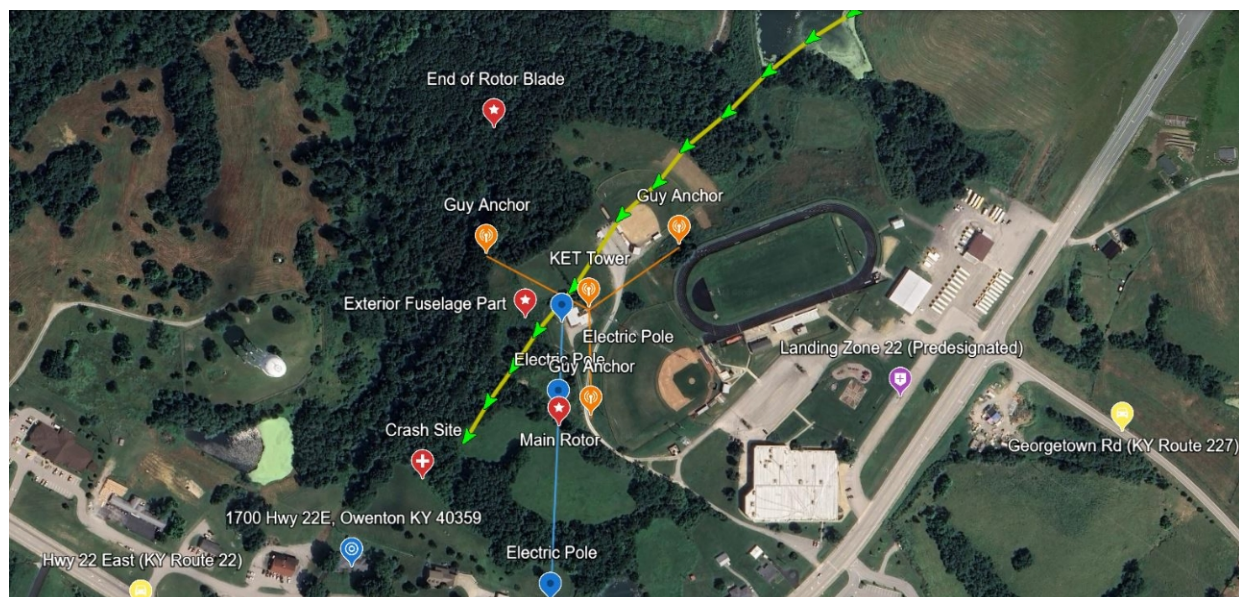
Several witnesses described that the helicopter approached from the north at "low altitude" with no unusual sounds or movements. A guyed television signal transmission tower, with a height of 601 ft above ground level (1,559 ft mean sea level) was located on the high school campus adjacent to the LZ. The witnesses saw the helicopter strike one of the guy wires supporting the tower before it descended to ground contact. Several detailed written statements described watching the helicopter strike the wire, watching the wire "move," and "pieces"; more specifically, the main rotor, separate from the helicopter, before the helicopter and the main rotor system descended separately to the ground.

ADS-B track data revealed that the helicopter approached the tower from the northeast on an approximate ground track of 210° magnetic at an altitude of about 1,300 ft msl. At the time,

the sun was 18° above the horizon on an azimuth of 246°. Figure 1 shows the area of the accident site including the helicopter's ADS-B ground track, the guyed tower, and the LZ.

Figure 1 - Aerial image with the helicopter's ground track, as well as positions of the accident site, select pieces of wreckage, the tower and guy anchors, and the LZ annotated.

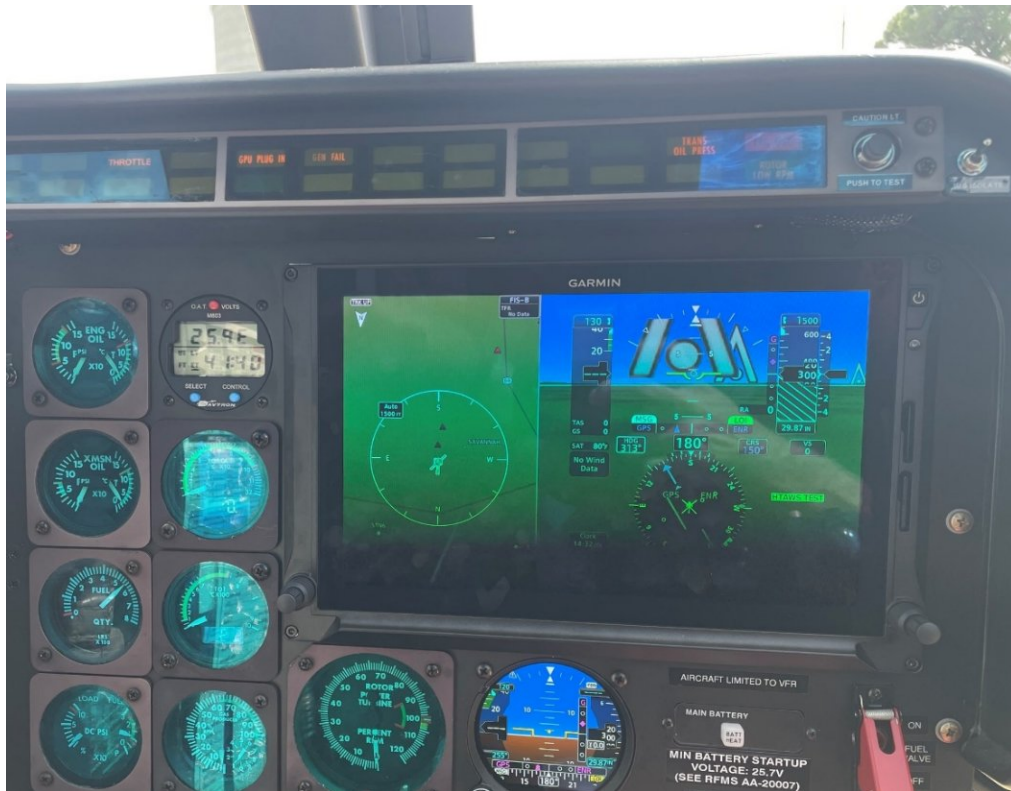
The helicopter was equipped with a two-axis autopilot, a Garmin 650 GPS, a Garmin 500txi cockpit display, synthetic vision, and a Helicopter Terrain Awareness and Warning System (HTAWS). These systems provided both visual and aural terrain and obstacle advisories to the pilot and crew. Figure 2 shows an exemplar instrument panel including terrain and obstacle awareness displays.

Figure 2 - Exemplar of instrument panel as configured in accident helicopter.
