# Aviation Investigation Preliminary Report

| <b>Location:</b> | Canton, MS | <b>Accident Number:</b> | CEN25MA115 |
| <b>Date &amp; Time:</b> | March 10, 2025, 12:37 Local | <b>Registration:</b> | N835CS |
| <b>Aircraft:</b> | EUROCOPTER DEUTSCHLAND<br>GMBH EC 135 P2+ | <b>Injuries:</b> | 3 Fatal |

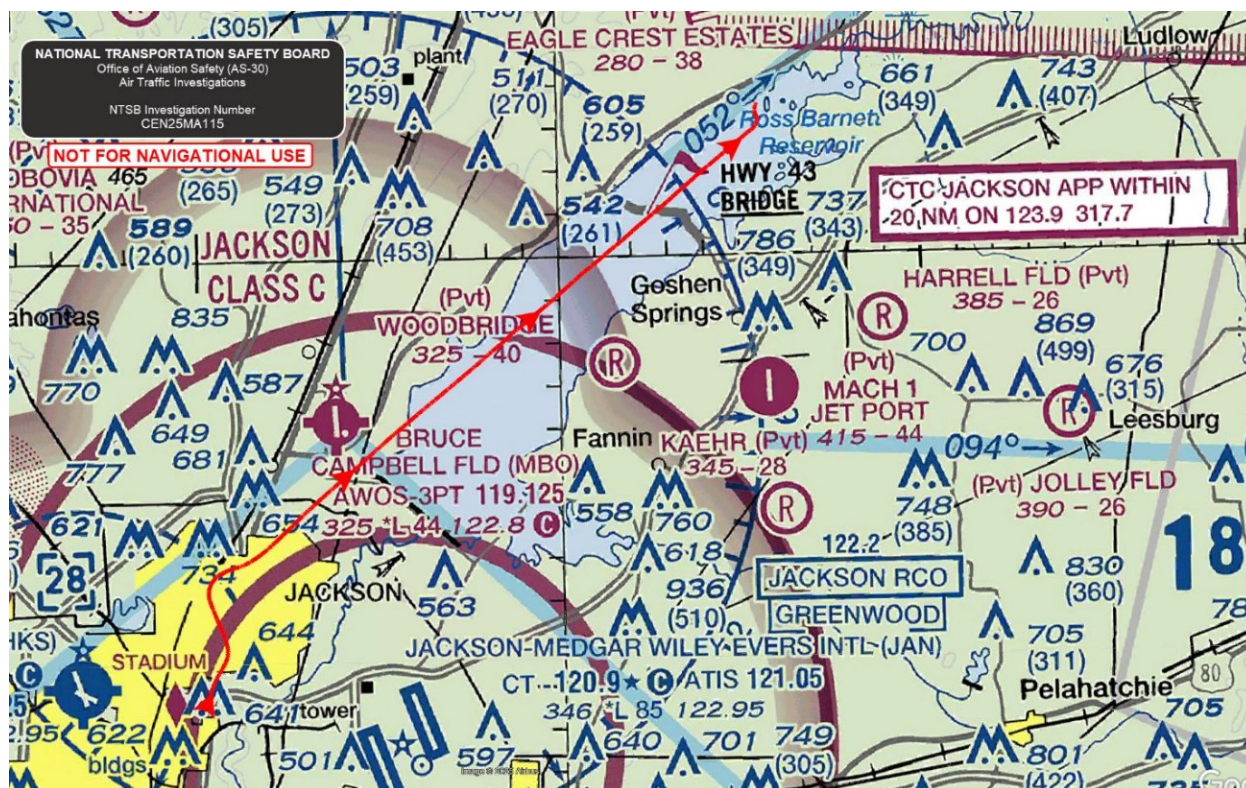
**Figure 1.** The accident flightpath, shown in red, overlaid on a visual flight rules sectional chart.

A preliminary review of automatic dependent surveillance-broadcast (ADS-B) data showed the helicopter departed from MS46 and began to climb to the northeast. The helicopter flew over the Ross R. Barnett Reservoir, and the flightpath remained south of the Natchez Trace Parkway, as shown in figure 1. The helicopter eventually reached an altitude of about 2,500 ft above mean sea level (msl).

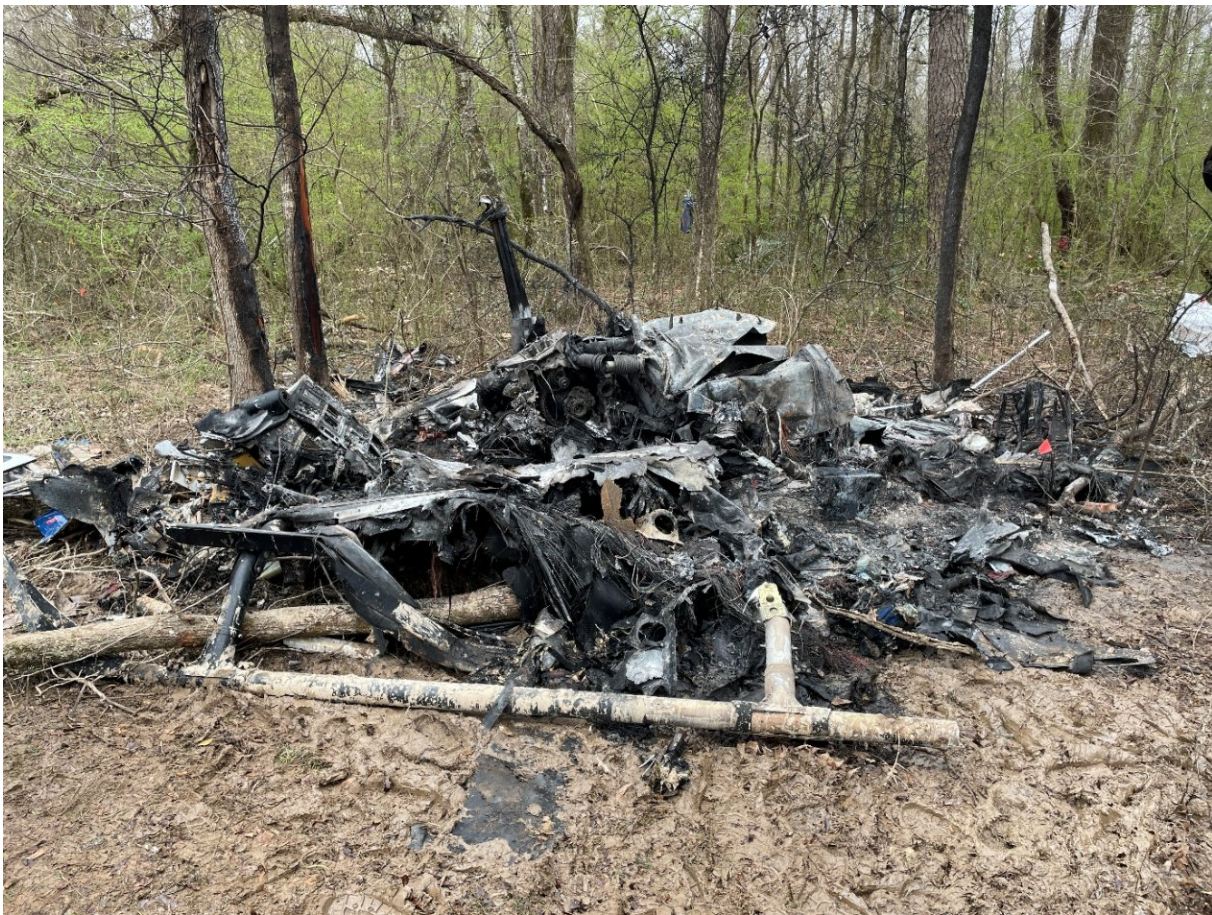
**Figure 3.** The destroyed helicopter at the accident site.

The National Transportation Safety Board, the FAA, Airbus Helicopters, Med-Trans Corporation, and Global Medical Response traveled to the accident site. Due to postcrash fire damage as shown in figure 3, none of the helicopter systems could be functionally tested.

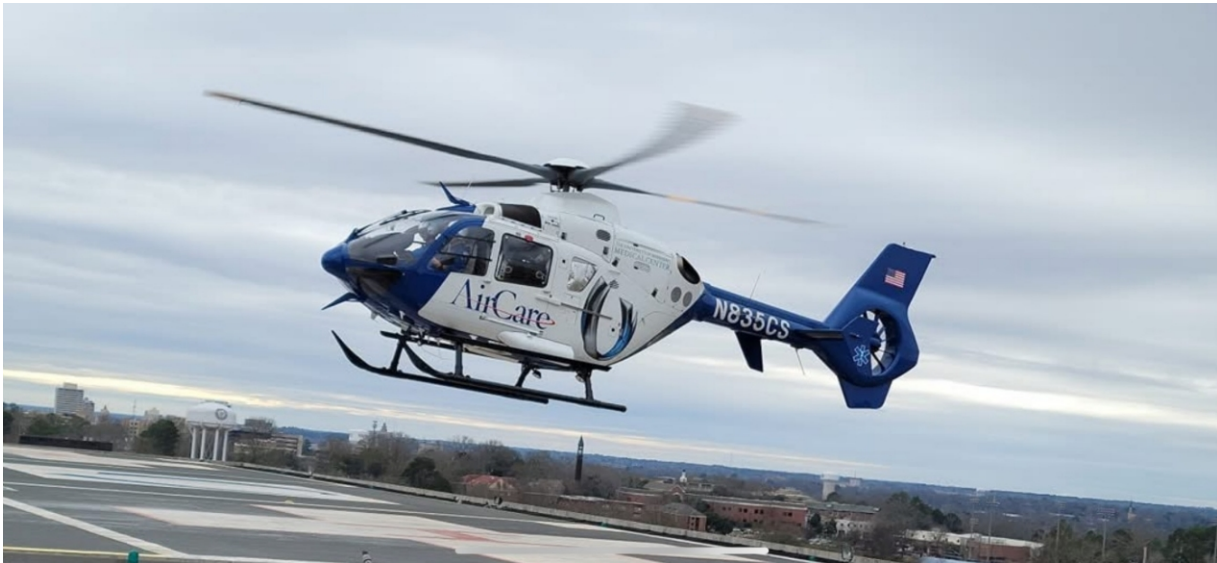
The helicopter was manufactured in 2012 (figure 4 is a pre-accident photograph of the helicopter). It was equipped with two Pratt & Whitney Canada PW206B2 turboshaft engines, an autopilot system, and a crash-resistant fuel system. The helicopter was transferred to the Med-Trans operating certificate in 2020. The helicopter underwent its most recent inspection during an approved aircraft inspection program, which was about 2.7 hours before the accident.

**Figure 4.** The helicopter before the day of the accident (Source: Med-Trans Corporation).
